EXHIBIT 7

Part 2

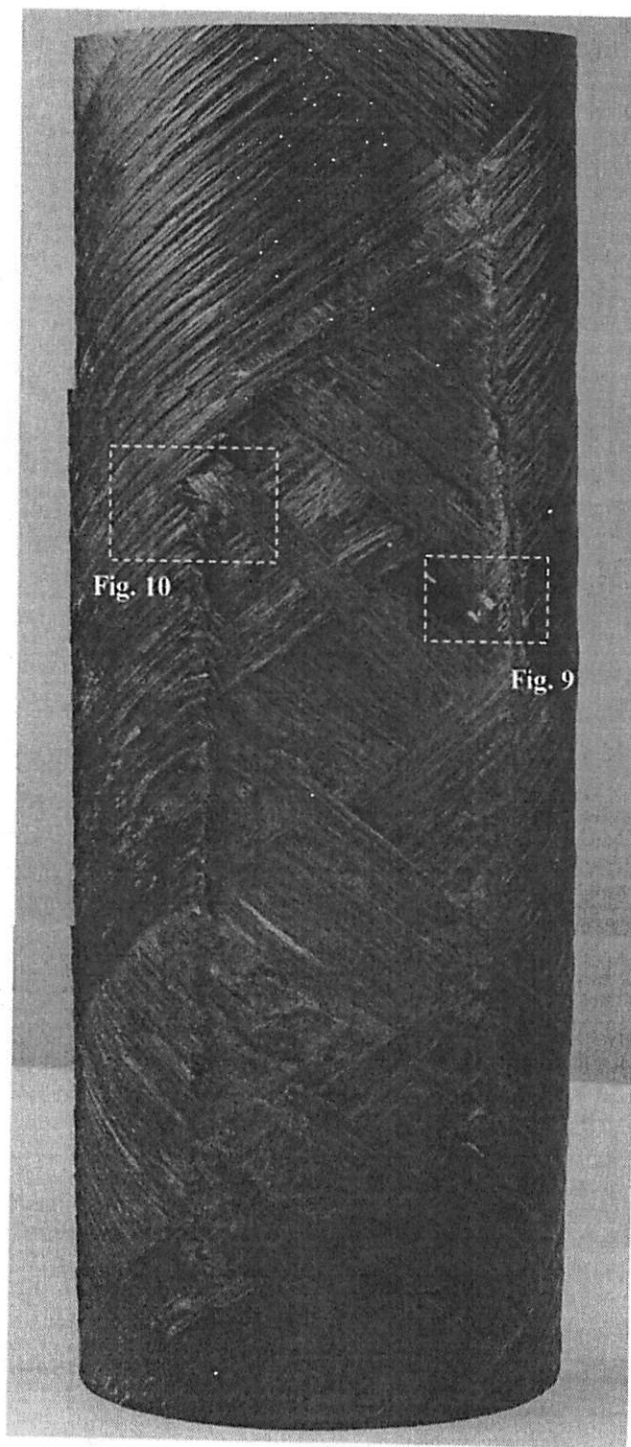
Figure 8. Photographic montage of the scrape.

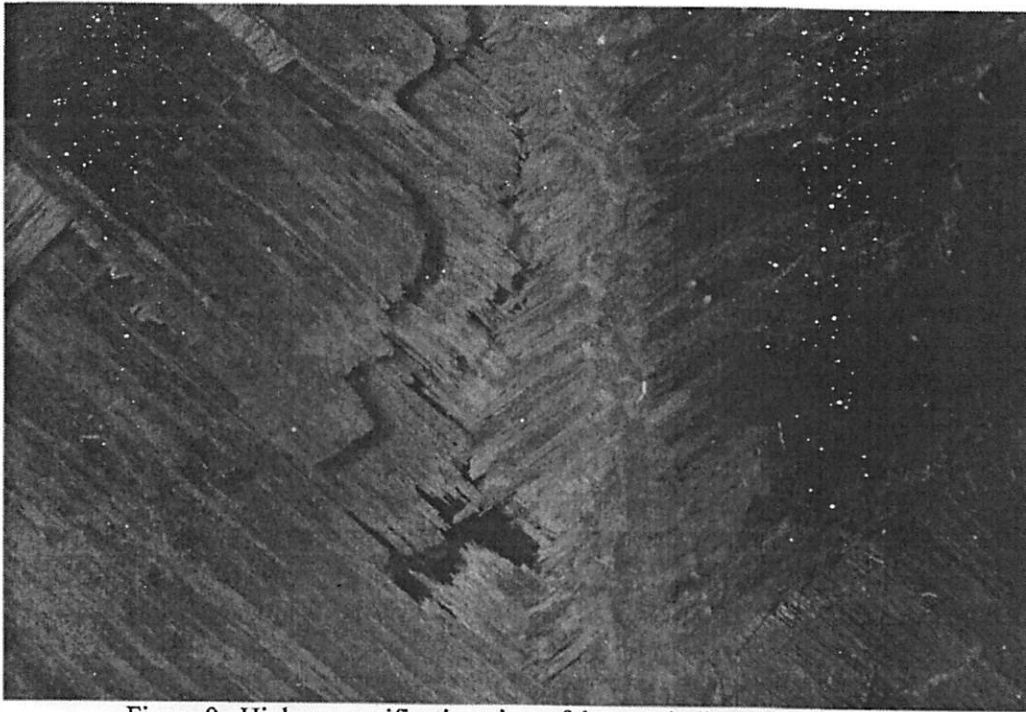
Figure 9. Higher magnification view of damage indicated in Figure 8.

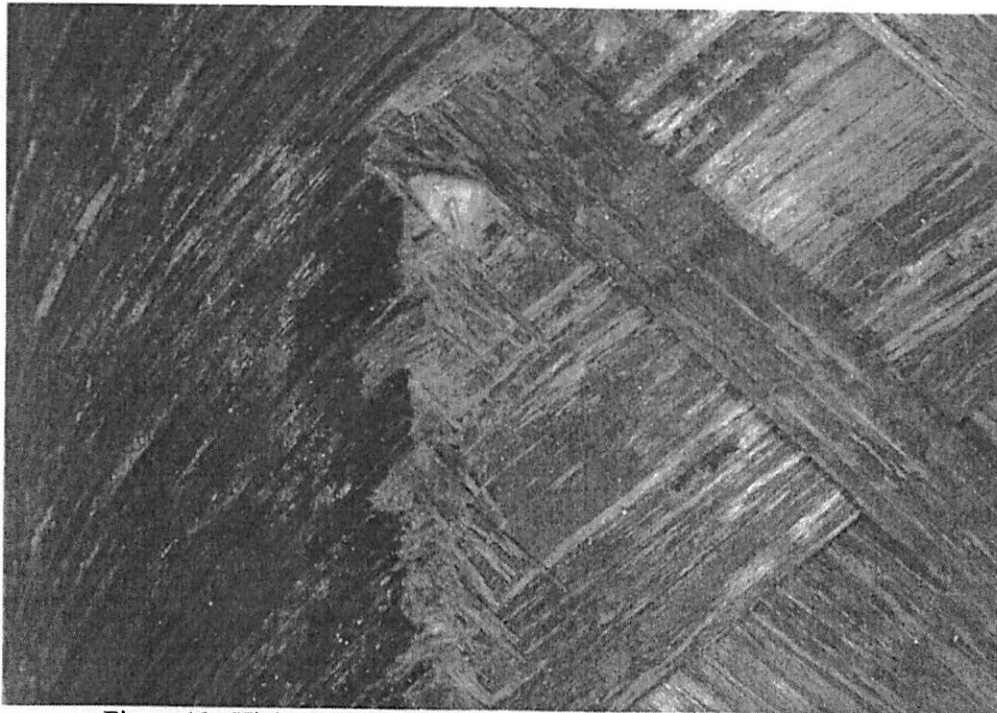
Figure 10. Higher magnification view of damage indicated in Figure 8.

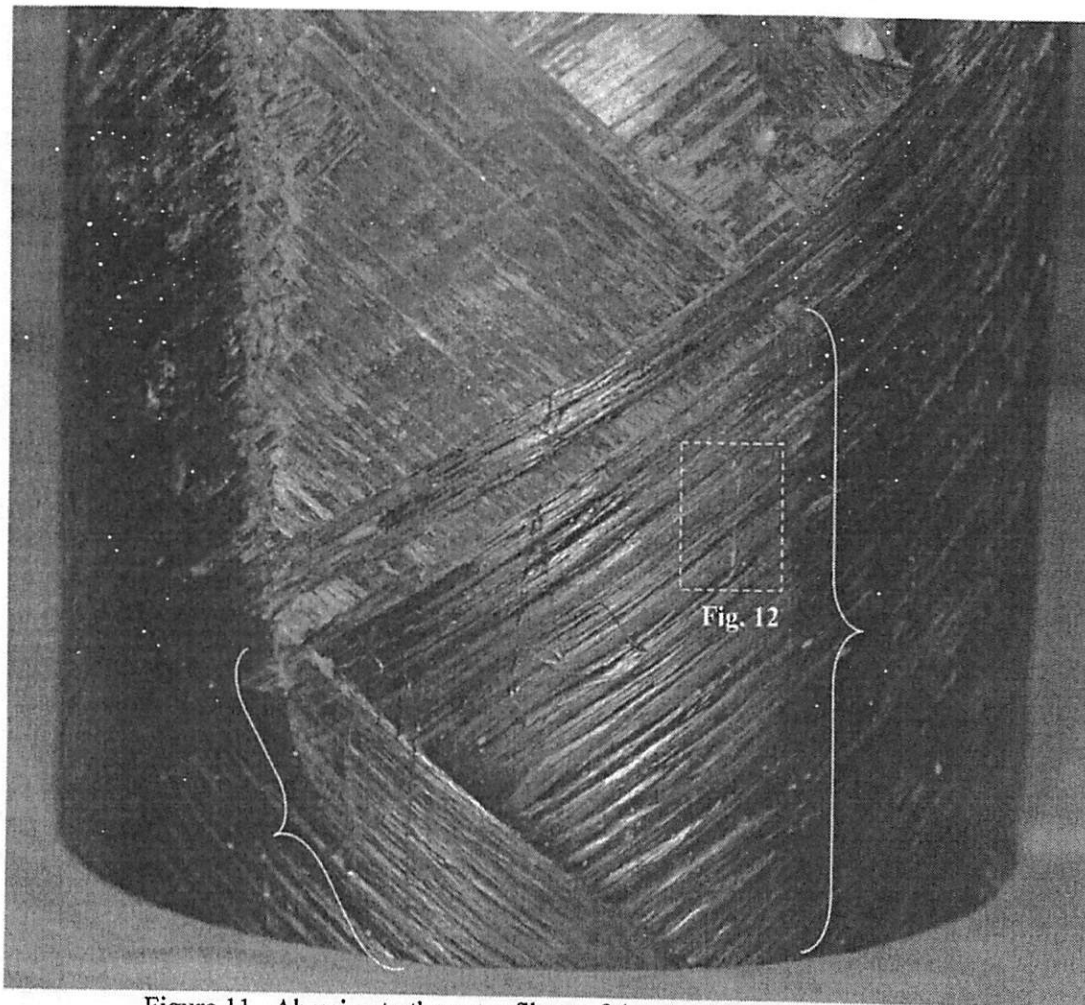
Figure 11. Abrasion to the outer fibers of the pipe (indicated by braces).

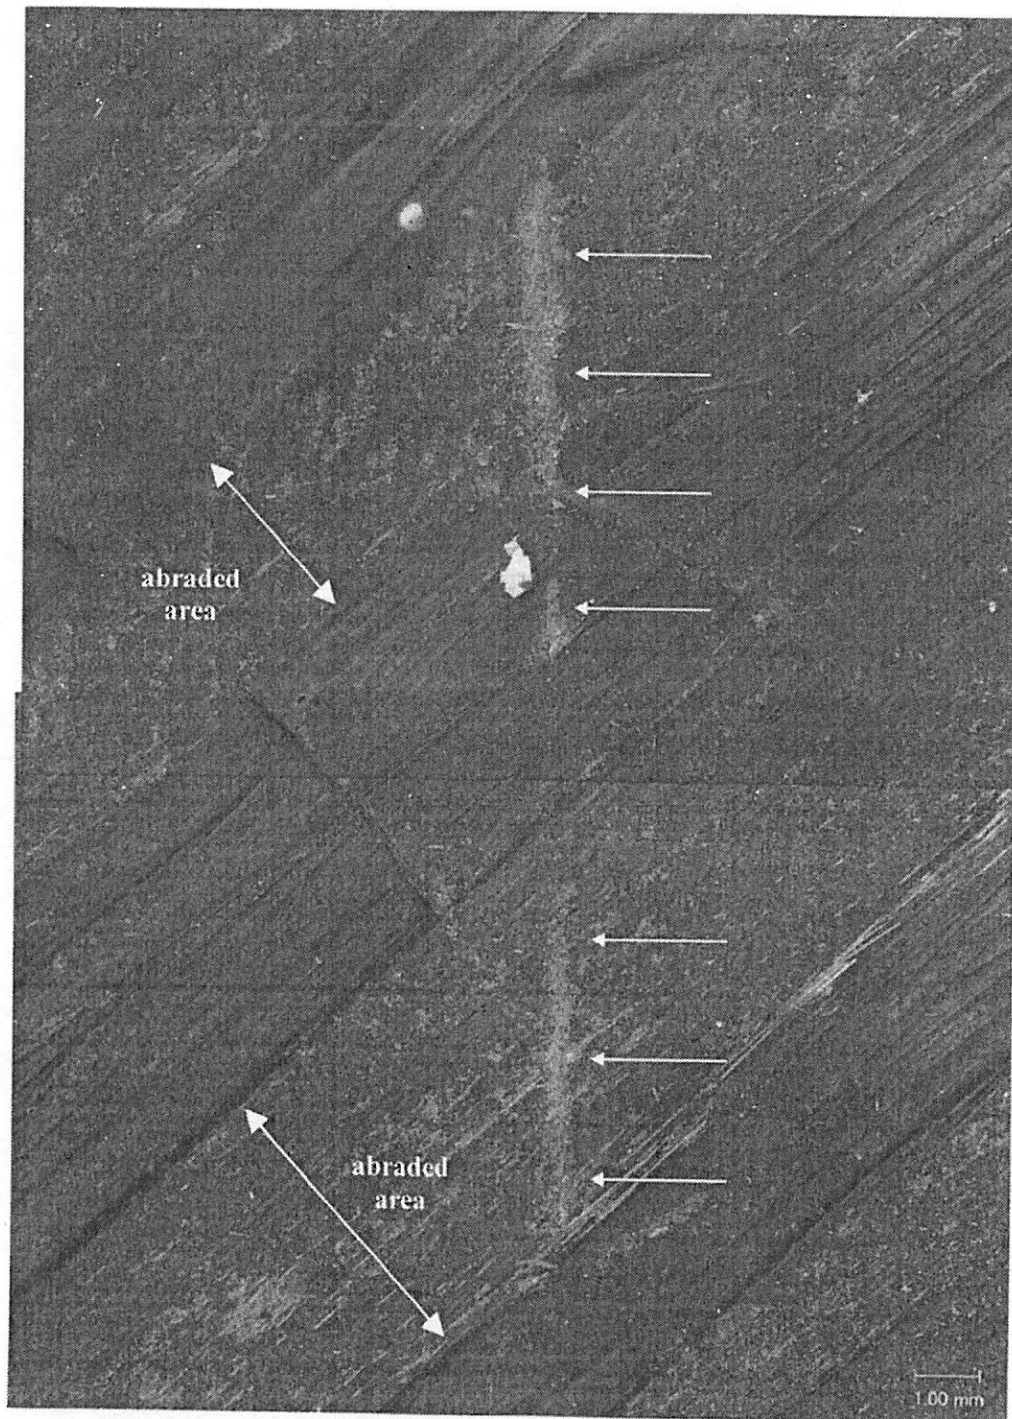
Figure 12. Microscope images of abraded raised areas on the outer surface of the pipe. An axial scratch is indicated by arrows.

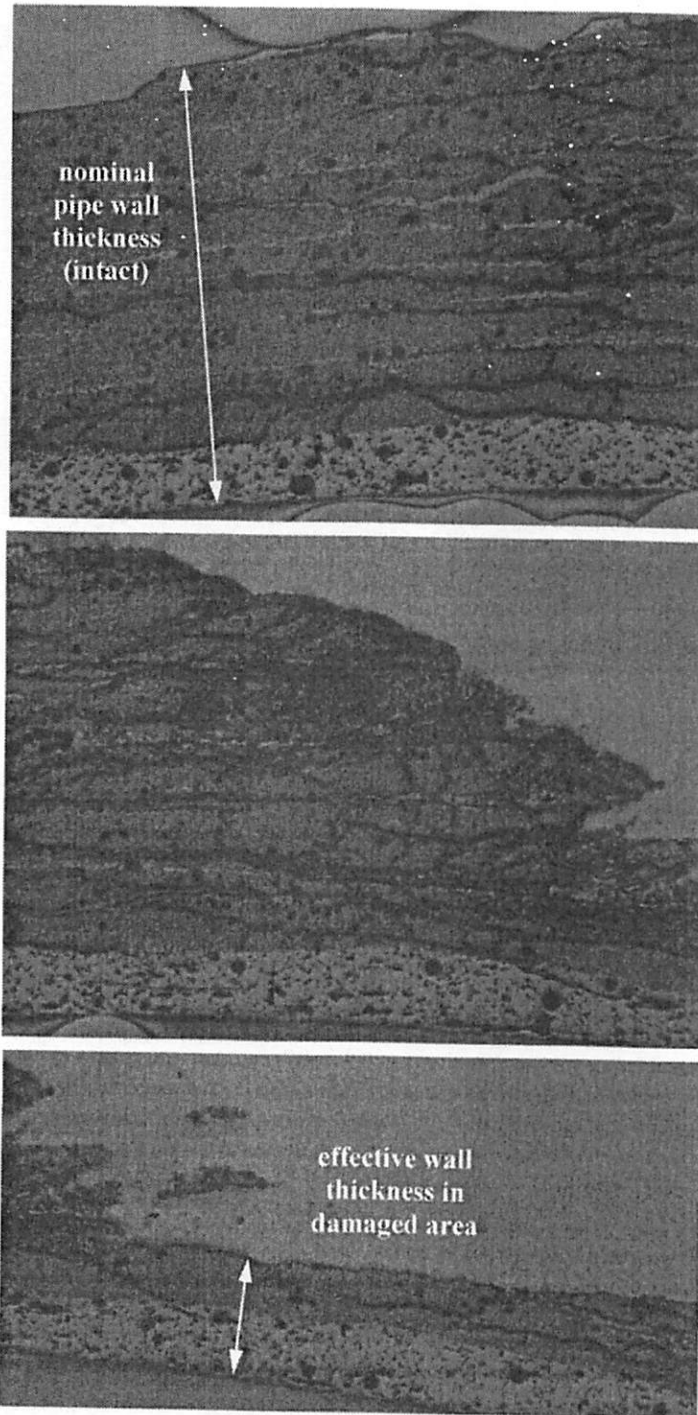
Figure 15. Item 3-2 (see Figure 14). Metallographically polished section showing transition/reduction in wall thickness into damaged area of pipe.

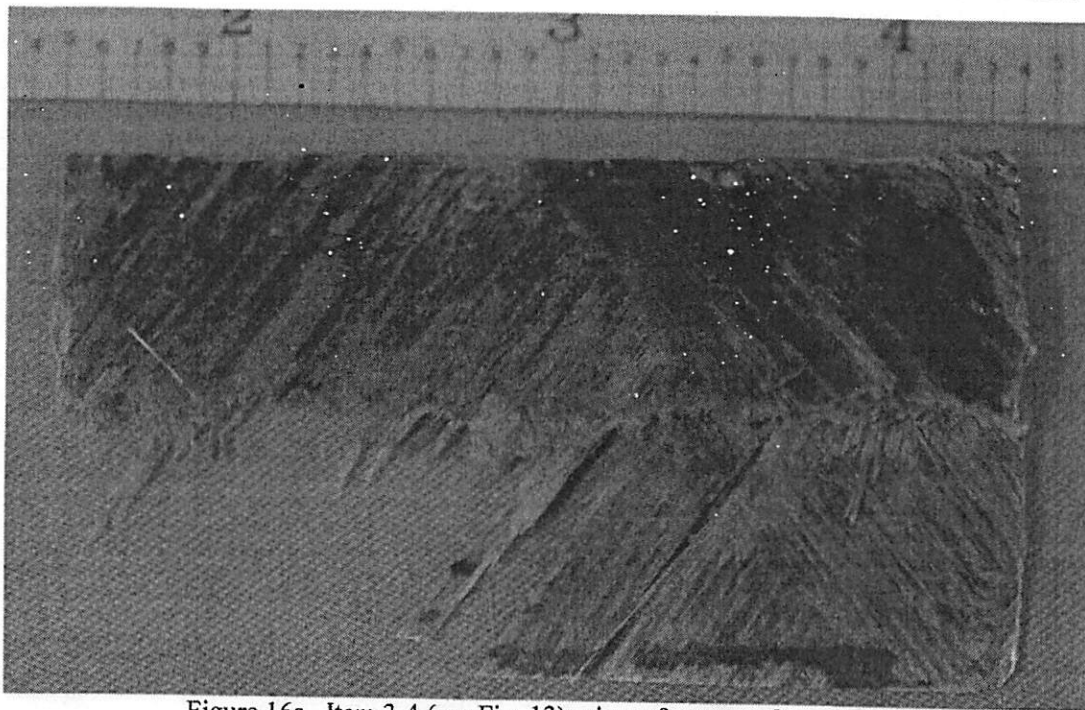
Figure 16a. Item 3-4 (see Fig. 13): view of outer surface of pipe.

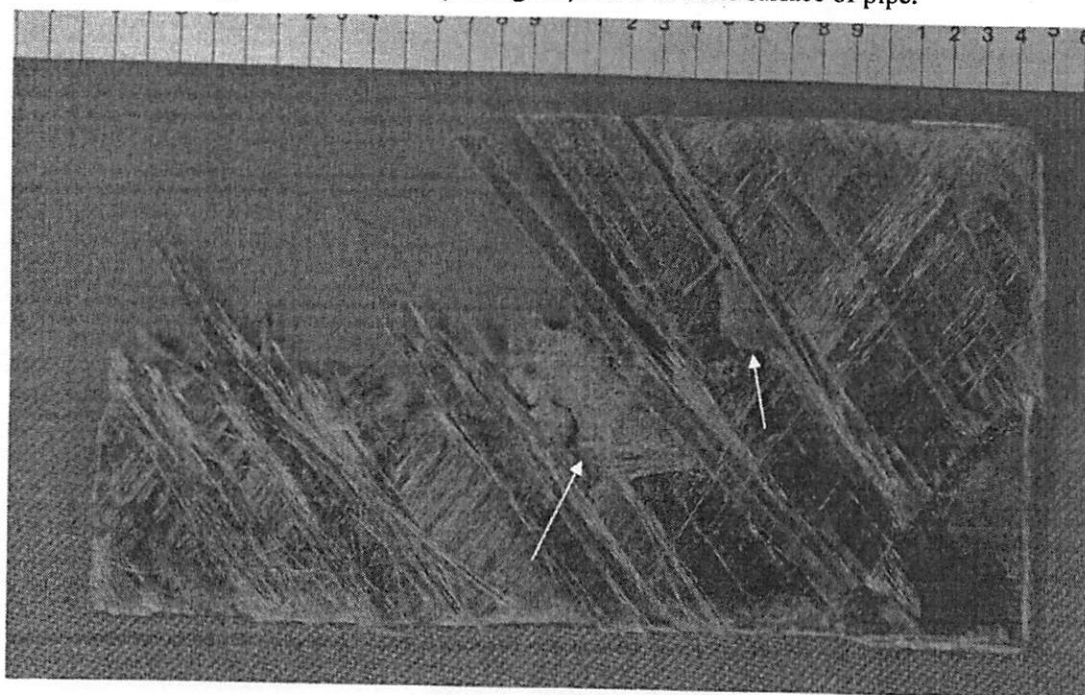
Figure 16b. Item 3-4 (see Fig. 13): view of surface formed
by delamination (bottom surface of Fig. 15a).

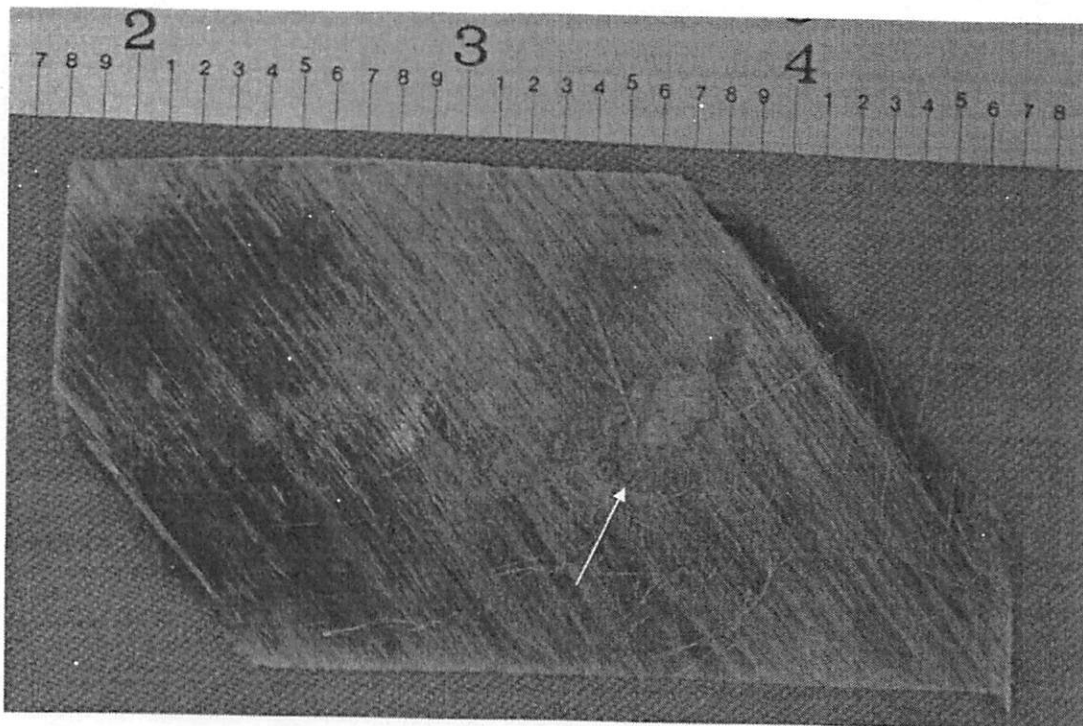
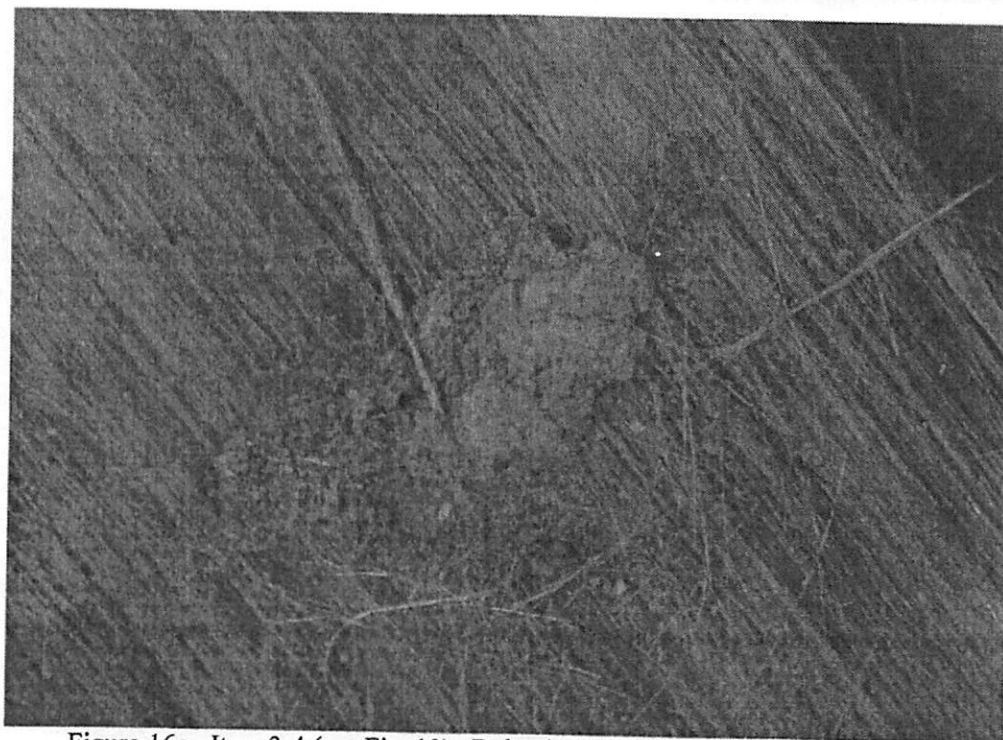
Figure 16c. Item 3-4 (see Fig. 13). Delaminated surface. Mate to Figure 15b.
